**LEVEL 1 REPLACEMENT RESERVE REPORT FY 2024  
WESTBRIAR PLAZA CONDOMINIUM**

# REPLACEMENT RESERVE REPORT

## WESTBRIAR PLAZA CONDOMINIUM

VIENNA, VIRGINIA

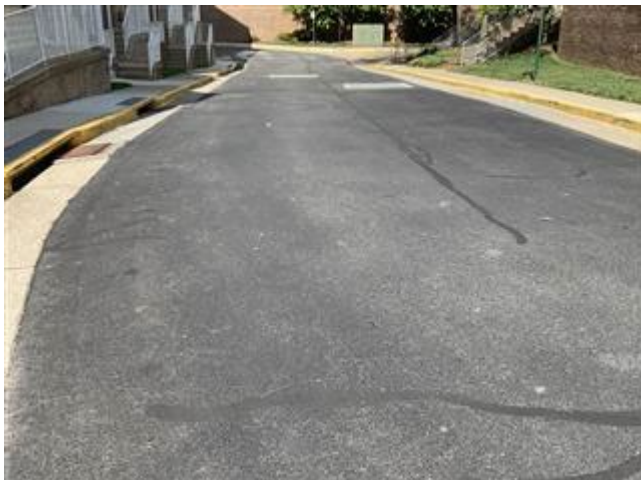
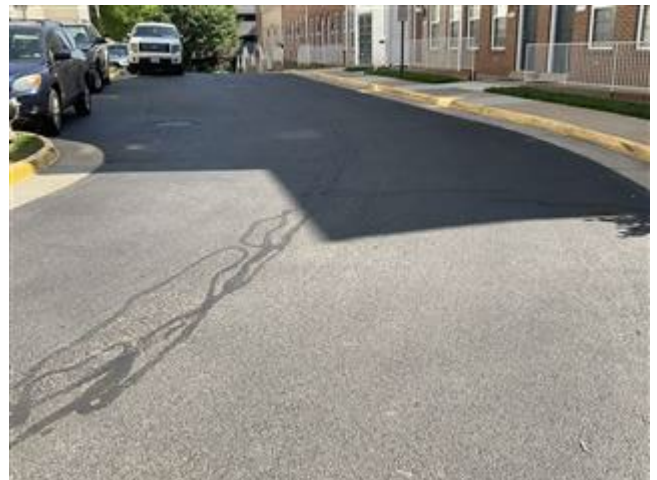
**Asphalt Pavement.** The Association is responsible for the roadways and parking areas within the community. Alleyways are not the responsibility of the Association. Other roadways are maintained by the City, County, or other municipality. The Association's asphalt pavements generally appear to be in good condition.

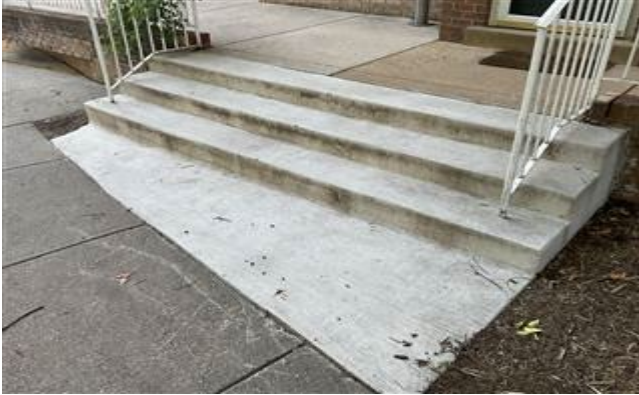
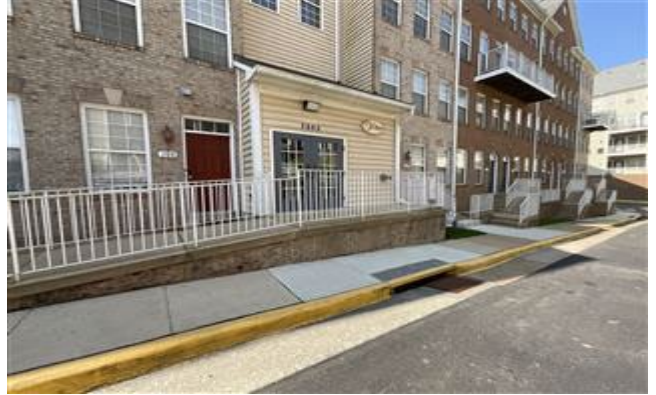
Because it is highly unlikely that all of the concrete components will fail and require replacement in the period of the study, we have programmed funds for the replacement of these inventories and spread the funds over an extended timeframe to reflect the incremental nature of this work.

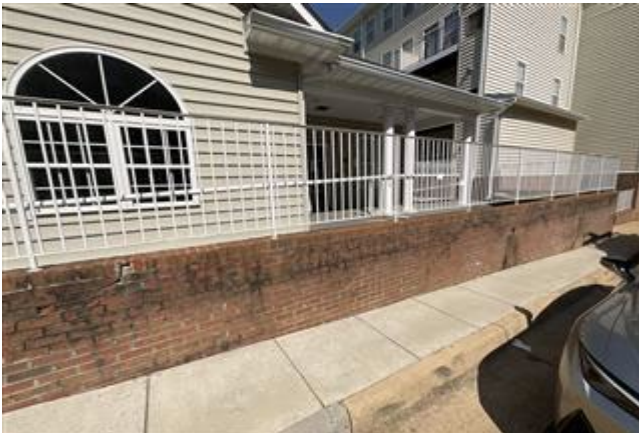
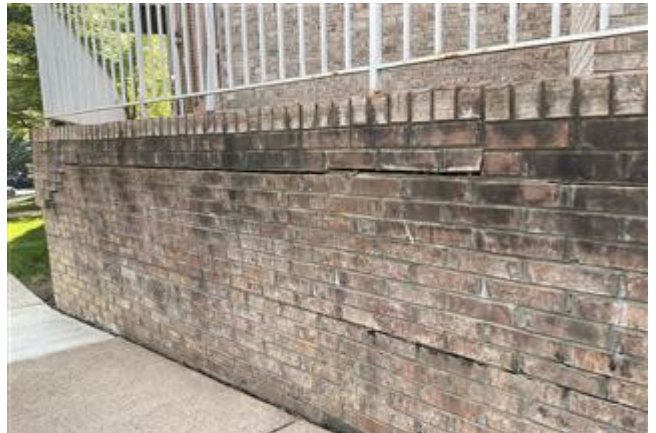
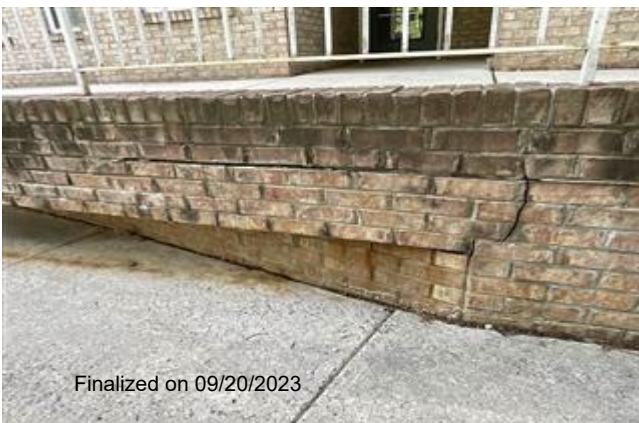
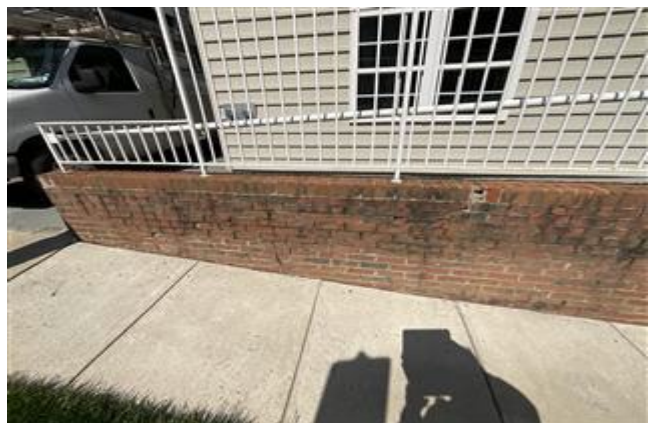
**Retaining Walls.** The Association maintains masonry and segmental block retaining walls. The retaining walls appear to be in mixed condition with moderate to severe leaning, bowing, and deterioration.

The movement and displacement of retaining walls are signs of general settlement or failure. This is in the form of leaning and bowing and can involve the entire wall or localized sections of the wall. Typically, these types of movements are gradual and may require the replacement of the wall. The movement of retaining walls located near other buildings or structures may negatively affect the stability of the adjacent structure. These conditions can become extremely costly if not properly identified, monitored, and addressed.

Brick masonry walls can have an extended useful life of 40 years or more and, if stable, may only require periodic tuckpointing and localized repair. Tuckpointing is the process of raking out defective masonry joints and tooling new mortar into the joints. Properly mortared and tooled joints will repel the weather and keep water from penetrating the wall. Siloxane or other breathable sealants should be considered to provide additional protection to the wall from water penetration. This study assumes that re-pointing will be performed incrementally as needed to maintain the life of the wall.

Segmental block retaining walls can have an extended useful life and if stable, are likely to only require localized resetting of displaced blocks, typically near the top of the wall. This study assumes that resetting will be performed incrementally as needed.

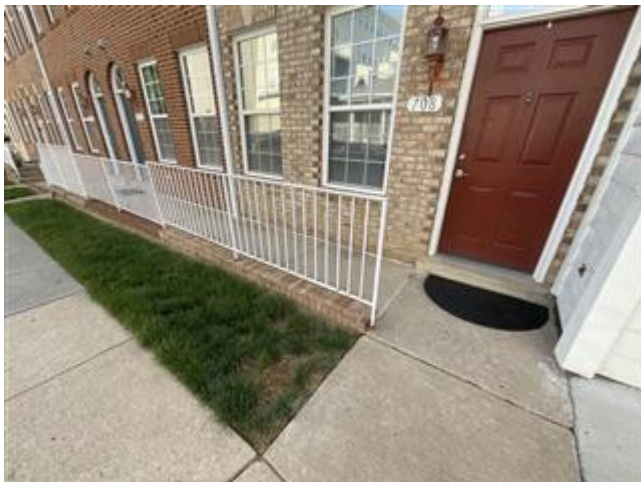
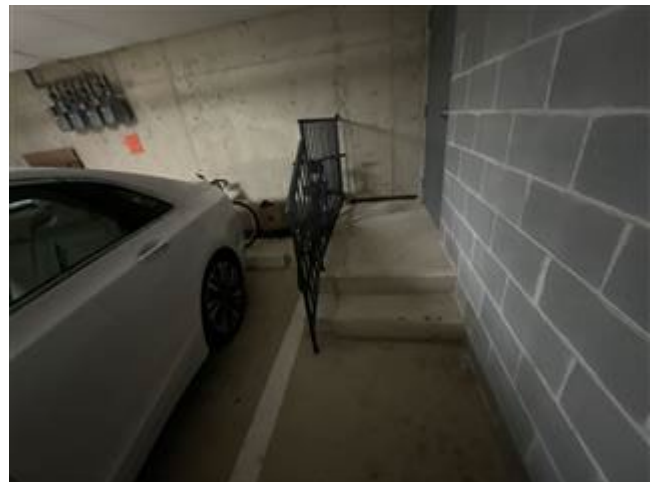
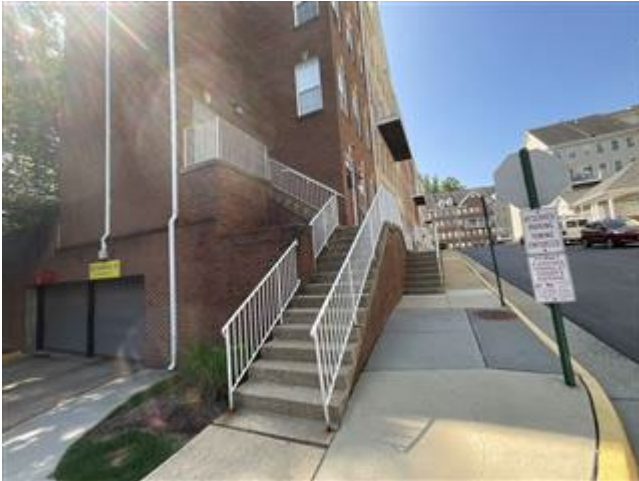
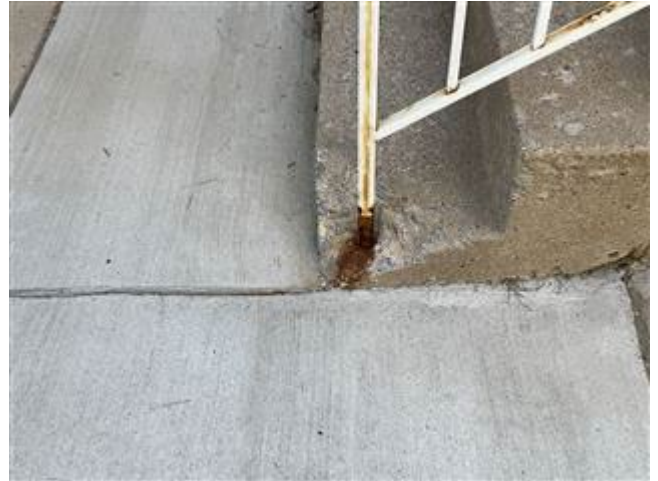
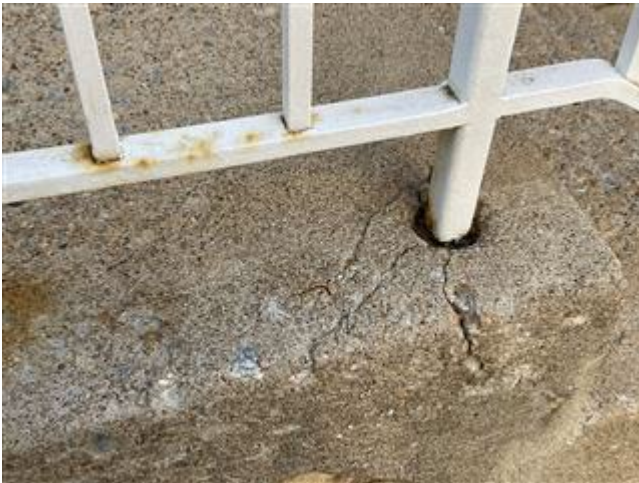
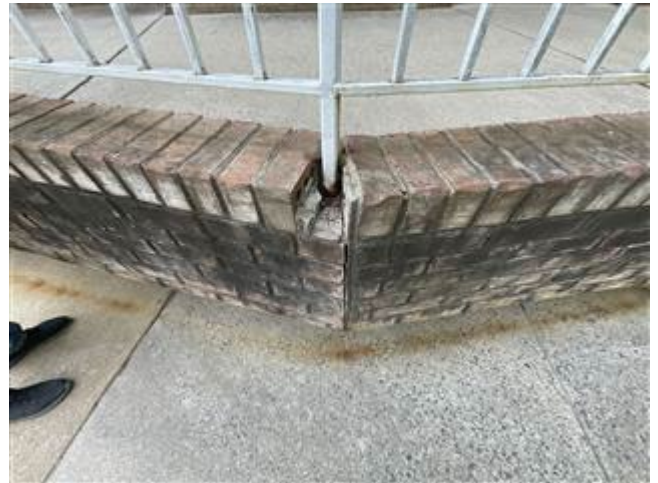
**Metal Hand Railing.** The Association maintains metal handrails and railing posts embedded in concrete or masonry. The handrails and railing posts appear to be in poor condition. We noticed signs of rust on 90% of the outdoor handrails.

Railings can have an extended useful life if these simple maintenance activities are performed regularly. If left unattended, the pressure from expansive post rust can crack and damage the supporting materials.

As part of routine maintenance, we recommend the following:

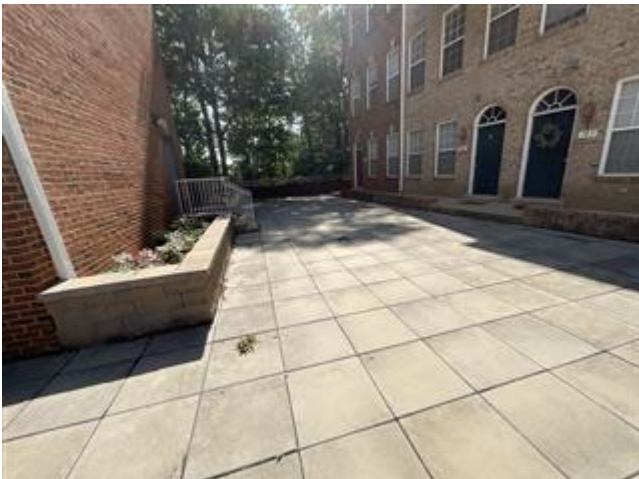
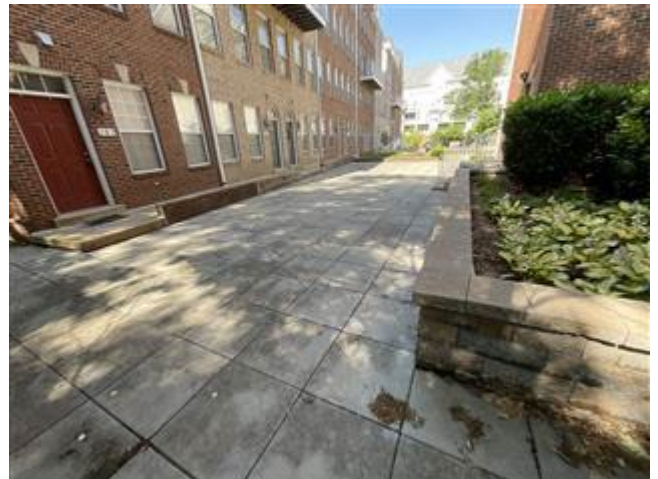
**Mortar Grouted Pavers.** Slate pavers provide a solid, decorative, and renewable surface that is part of the community's plazas. The overall condition of the mortar grouted pavers appears to be good, with areas of defects consistent with the age of the installation.

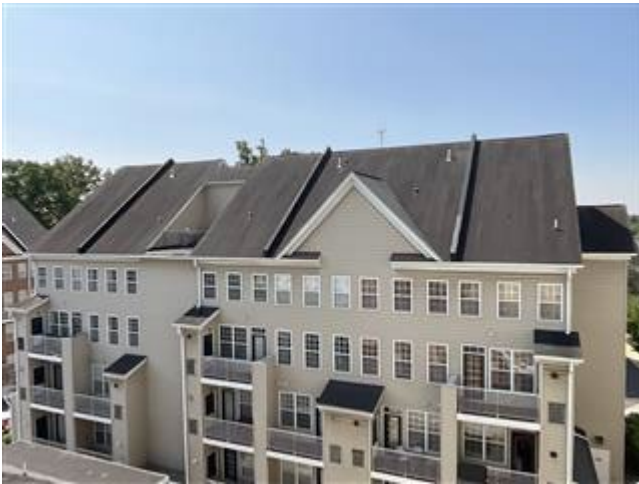
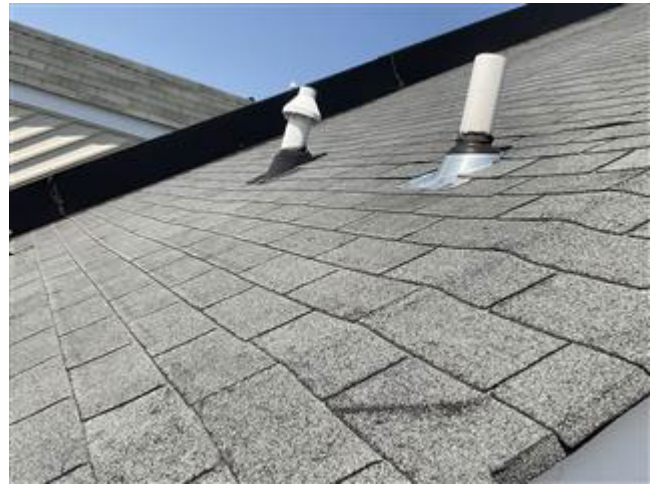
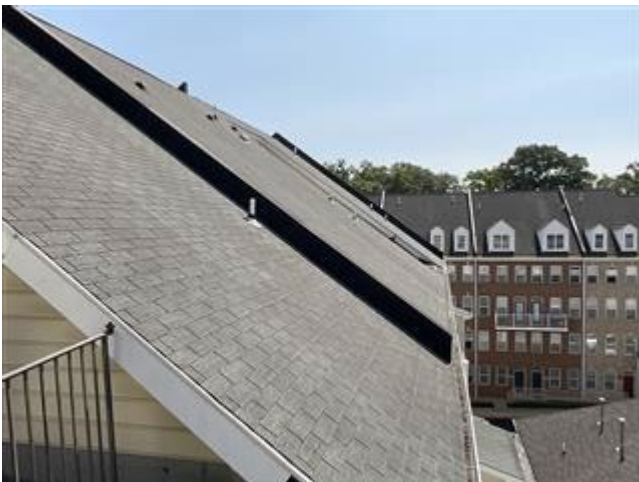
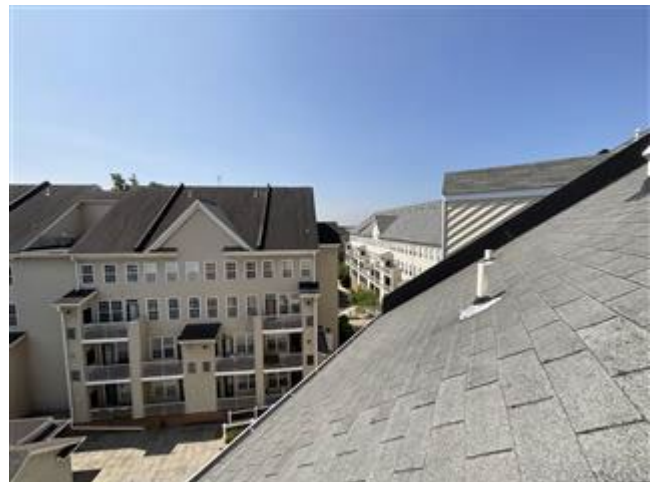
**Building Roofing.** All buildings have asphalt shingle roofs that appear to be in good condition.

Asphalt shingle roofs can have a useful life of 20 to 50 years, depending on the weight and quality of the shingle. Weathered, curled, and missing shingles are all indications that the shingles may be nearing the end of their useful life.

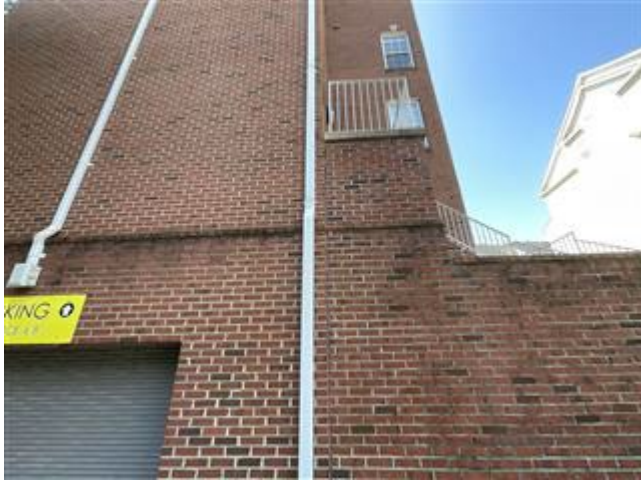
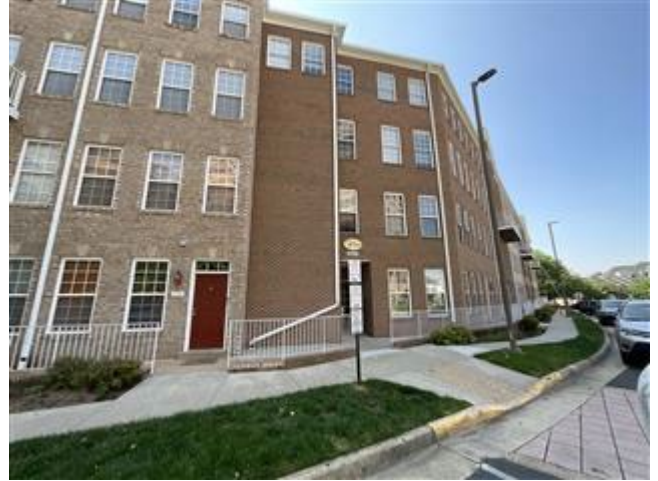
**Gutters and Downspouts.** The buildings have aluminum gutters and downspouts. The gutters and downspouts appear to be in good condition.

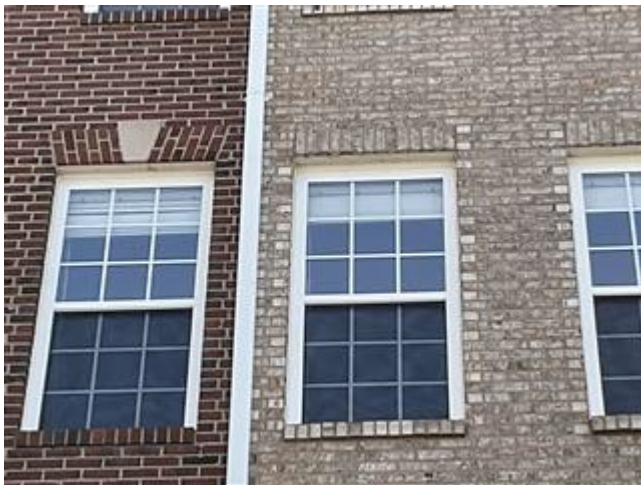
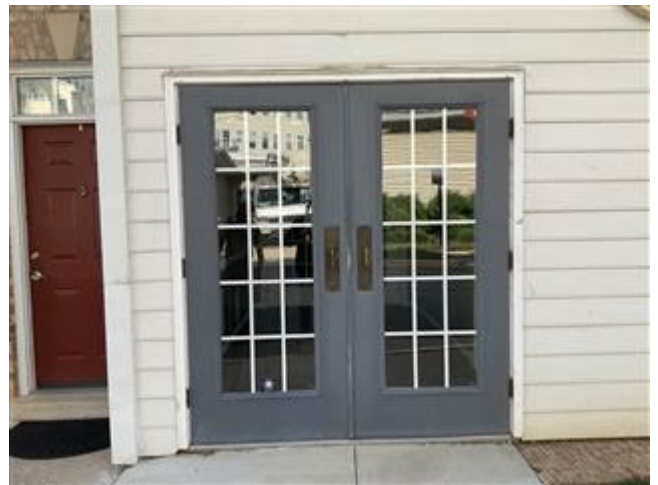
**Windows and Doors.** The Association is responsible for the common windows and exterior doors of the facility, and the individual owners are responsible for the windows and doors attributed to their unit. The windows and doors appear to be generally in good condition.

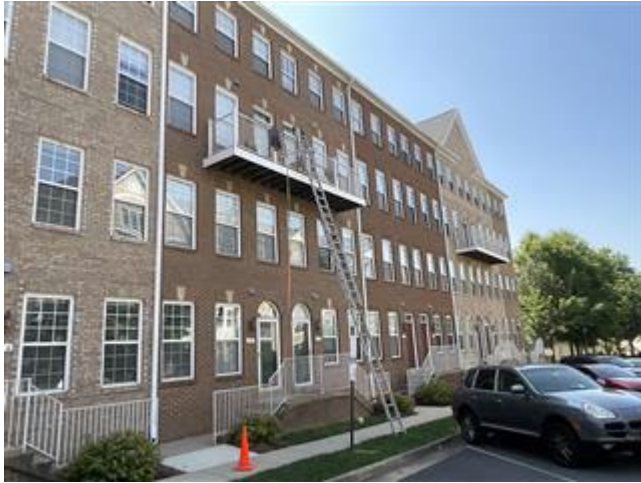
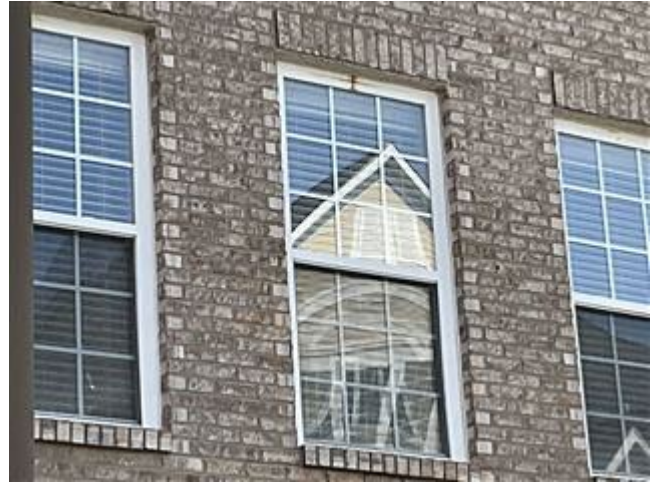
**Caulking.** The caulking on the facility's exteriors appears to be in fair condition.

Caulking and sealants play a primary role in protecting the facility's exterior components and the overall weather tightness of the facility. Caulking also provides a seal between dissimilar materials and changes in construction where movement is expected. We, therefore, recommend recaulking every ten years when painting or other exterior repairs and replacements are scheduled.

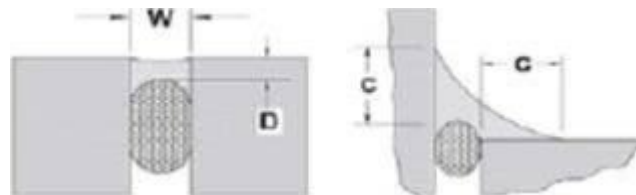
Any sealant application's minimum width and depth should be 1/4 by 1/4 (6mm by 6mm). The depth (D) of sealant may be equal to the width (W) of joints that are less than 1/2 wide. For joints ranging from 1/2 to 1 (13 mm to 25 mm) wide; the sealant depth should be approximately one-half of the joint width. The maximum depth (D) of any sealant application should be 1/2 (13 mm). For fillet beads or angle beads around windows, doors, soffits, and trim, the sealant should exhibit a minimum surface contact area (C) of 1/4 onto each substrate.

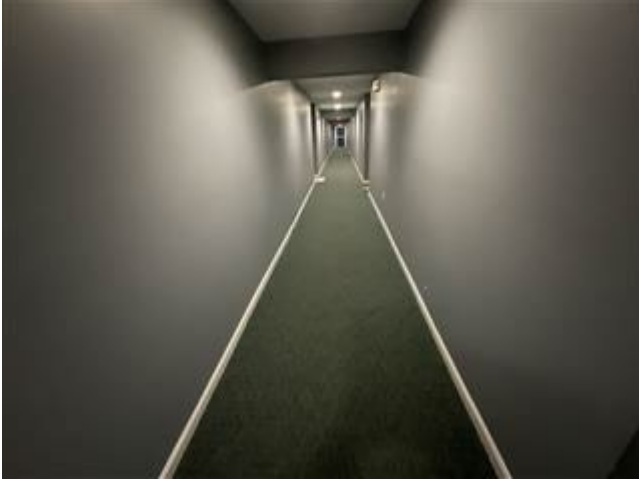
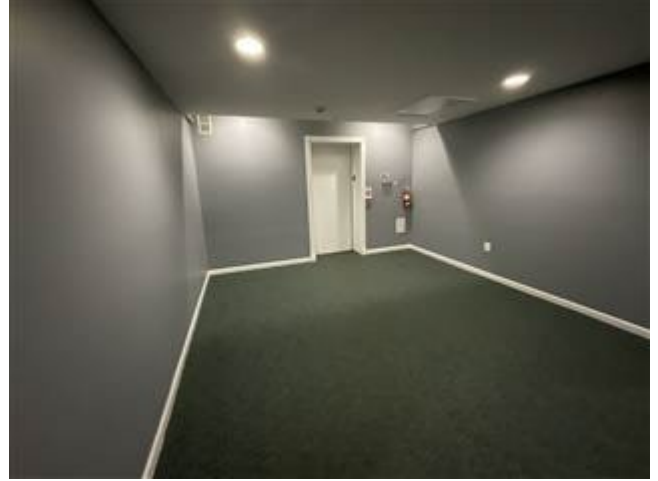
**Carpet.** The carpet in the building's corridors and lobby appears to be in good condition. The commercial carpet of this construction in this type of application has a typical service life of 7 to 10 years.

To extend the life of the carpet, it is important that the Association continues with a comprehensive maintenance program that includes regular vacuuming, spot and spill removal, interim cleaning of high-traffic areas, and regularly scheduled cleanings. It is also recommended that all entrances be fitted with walk-off mats to trap soil.

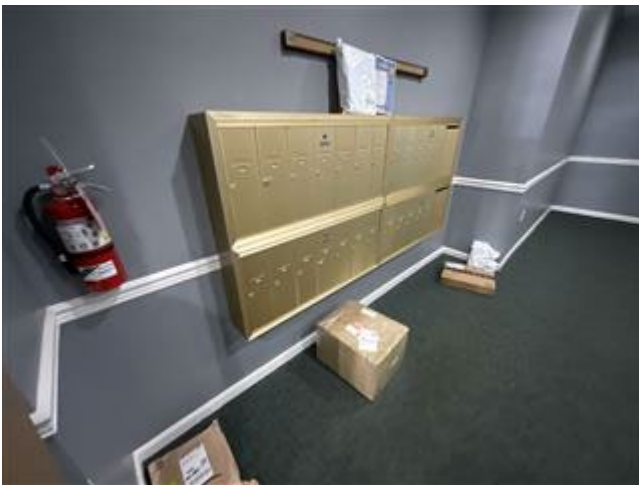
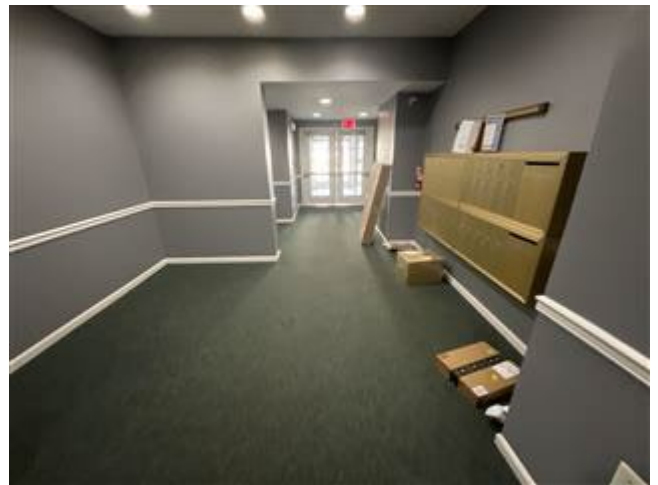
**Mailboxes.** Cluster mailboxes are located in the lobby of each building and appear to be in good condition.

Mailboxes should be maintained to the extent that rust does not develop on the structure, and all mail slot doors remain intact with operable hinges and locks. Our replacement estimate assumes that these units will be replaced with fiberglass or composite units in the future.

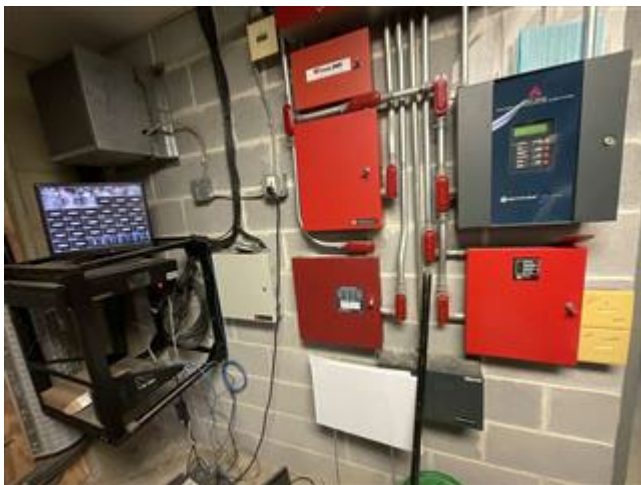
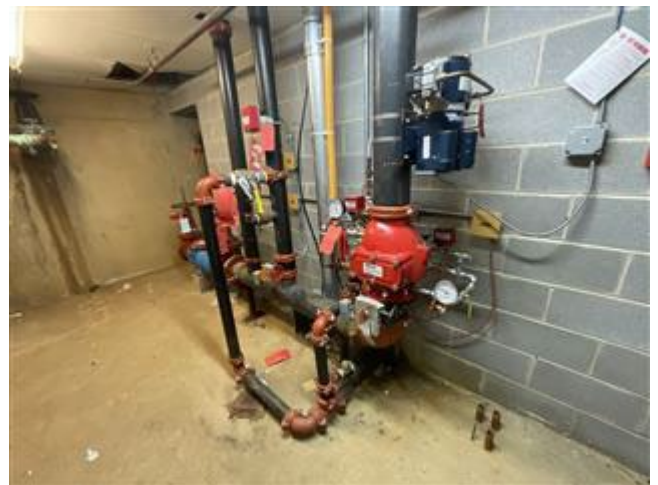
**Fire Safety Systems.** The building is fitted with a fire safety system that includes sprinklers and alarms, and these are reported to be operating normally. Testing and inspection of fire safety systems are not included in this study.

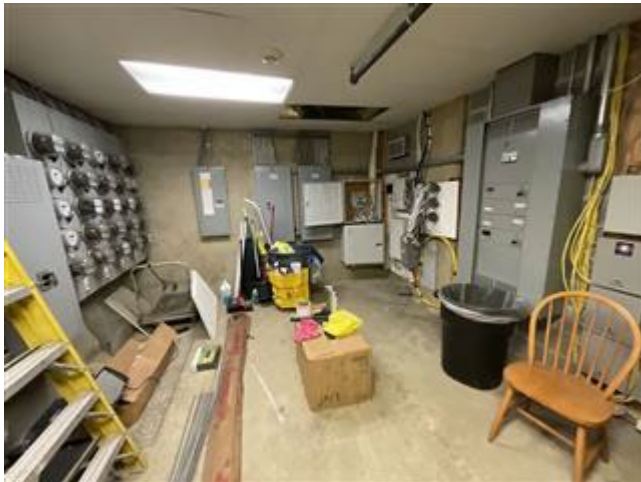
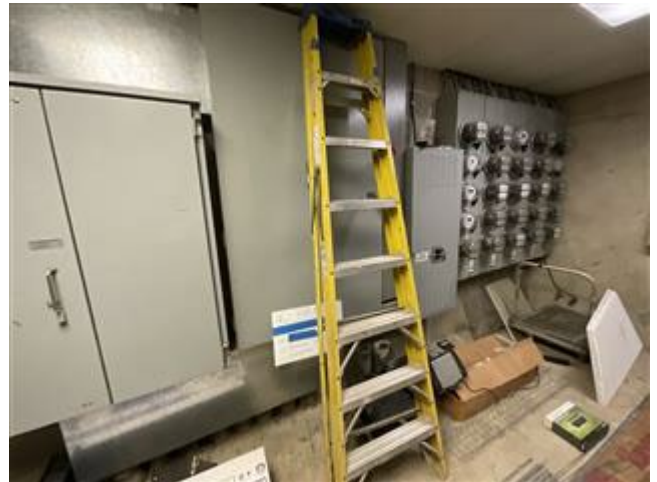
**Building Electrical Service.** The electrical systems of the building are reported to be operating normally.

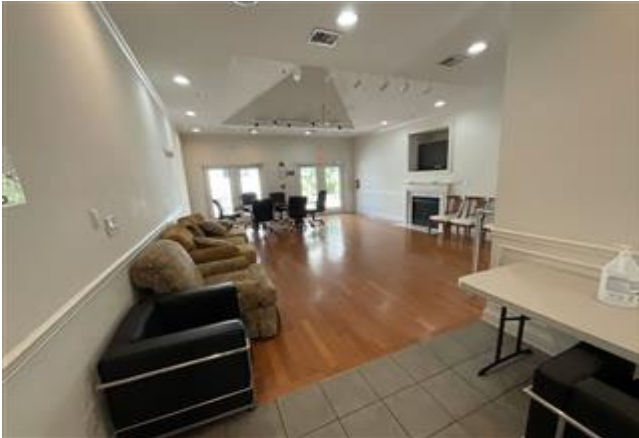
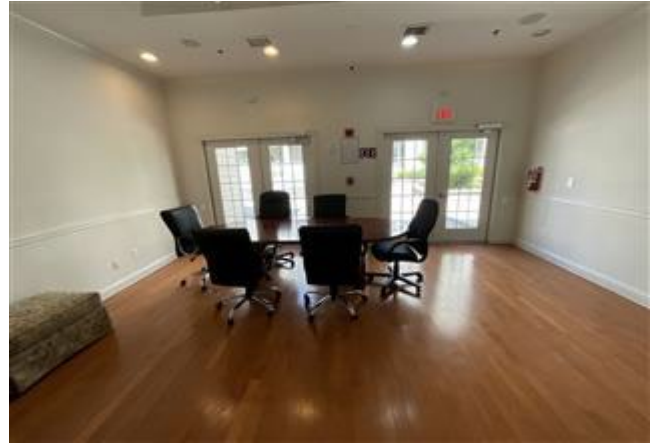
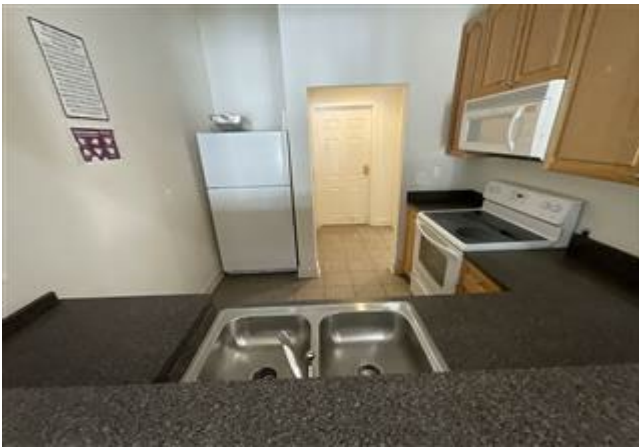
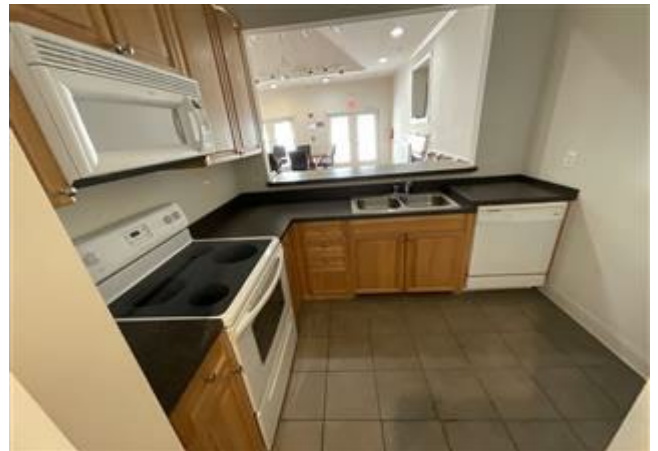
**Common Interiors.** The Association maintains a clubhouse and other common interior spaces that appear in generally good condition.

We have assumed that the Association will want to maintain these areas in a commercially acceptable condition. Typically, replacement cycles for common interior spaces vary between 5 to 10 years, depending on the aesthetic tastes of the community, usage, and construction. Material selection and the community's preferences are the major factors in setting the reserve components for items such as refurbishing and interior refurbishment. The Association will need to establish these cycles as these facilities age. Maintaining historical records and incorporating these trends and preferences into a future Reserve Study update is the best way to adjust for these cycles.

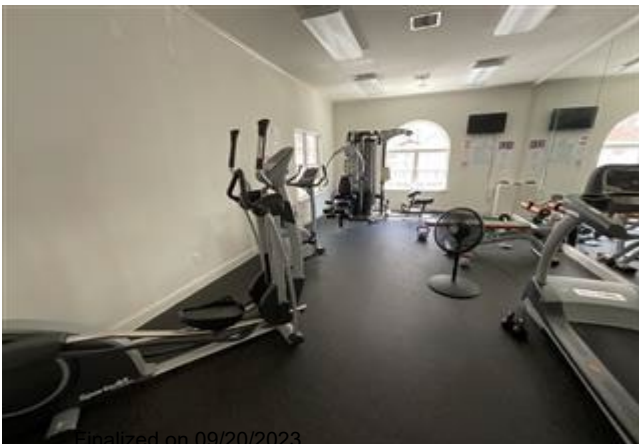
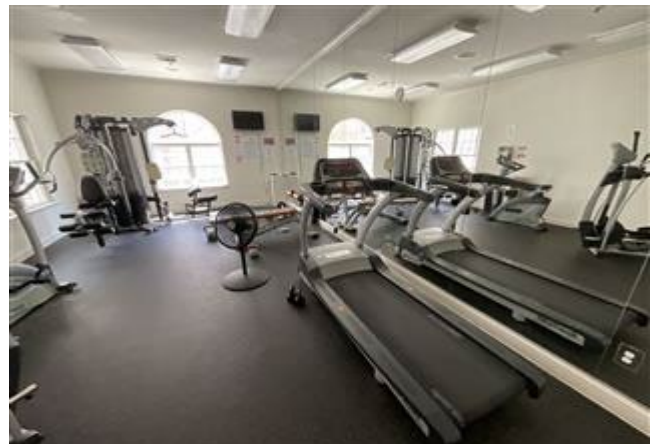
**Health and Fitness Center.** The Health and Fitness Center includes exercise equipment and two restrooms with a shower. Listed below are the major components:

- Flooring. The rubber floor appears to be in good condition. We have assumed a service life of 15 years.
- Exercise Equipment. The equipment appears to be in generally good condition. Since it is unlikely that all of the equipment will require replacement at the same time, we have provided a replacement-funding plan that assumes an incremental approach.
- Restrooms. The restroom fixtures and finishes appear to be in good condition overall. Restroom components typically have a service life of 20 years.

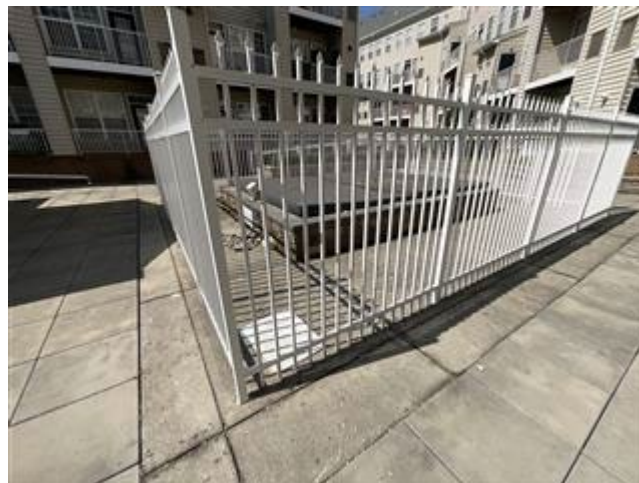
**Outdoor Spa.** The Association maintains an outdoor spa. The spa was reported to be in good working condition.

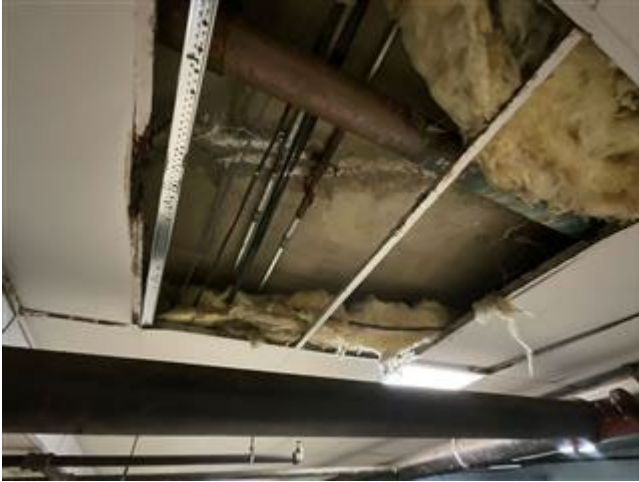
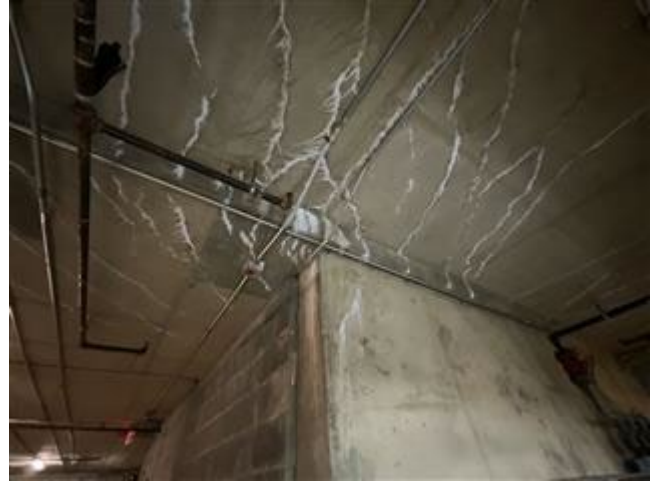
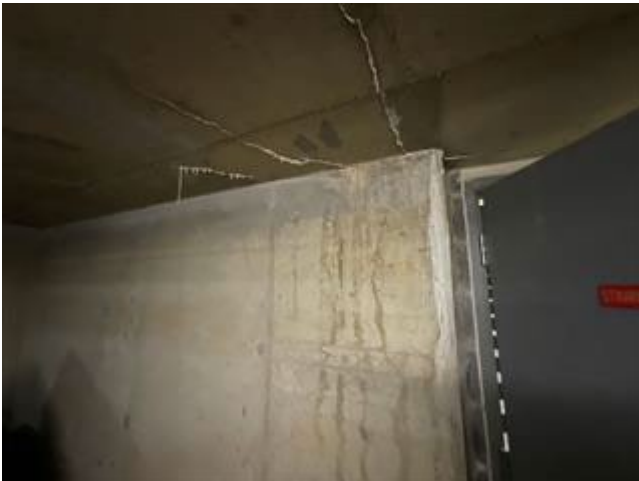
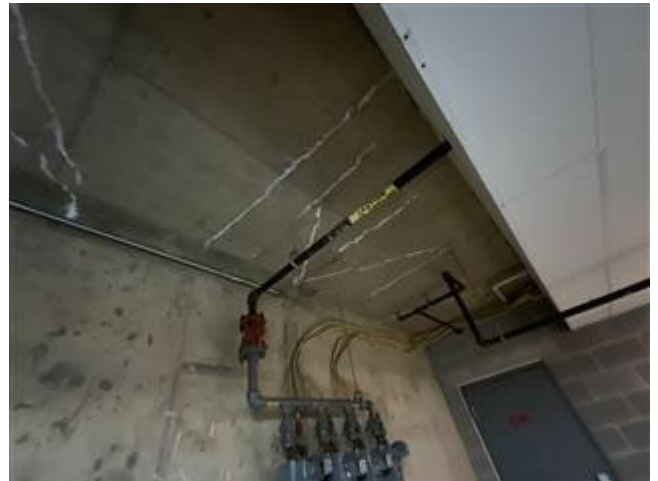
**Garage Slabs.** The Association maintains two under-building parking garages. The structural concrete slabs appear in fair condition with large water penetration areas. A structural evaluation of the buildings and building components is beyond the scope of this study. We recommend having a thorough structural evaluation performed by a qualified Professional Engineer as soon as possible.

Afterward, we recommend the application of coating sealants for the structural slabs of the garage. Several reputable companies, such as Sika Corporation, provide sealant systems for garages of this type. We recommend contacting the representatives of these companies to aid in developing appropriate sealant systems for the Association's garage.

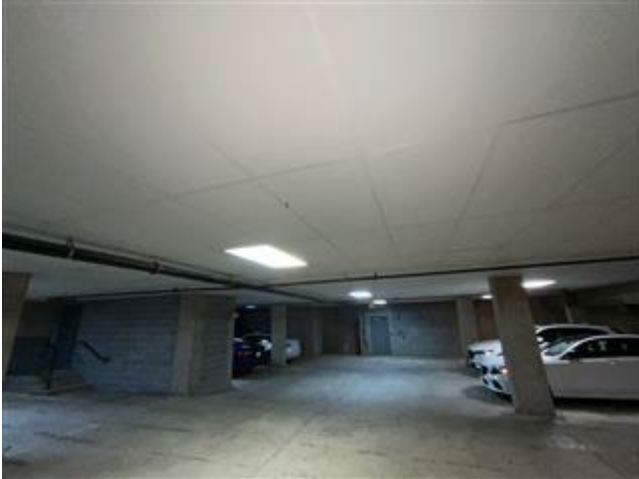
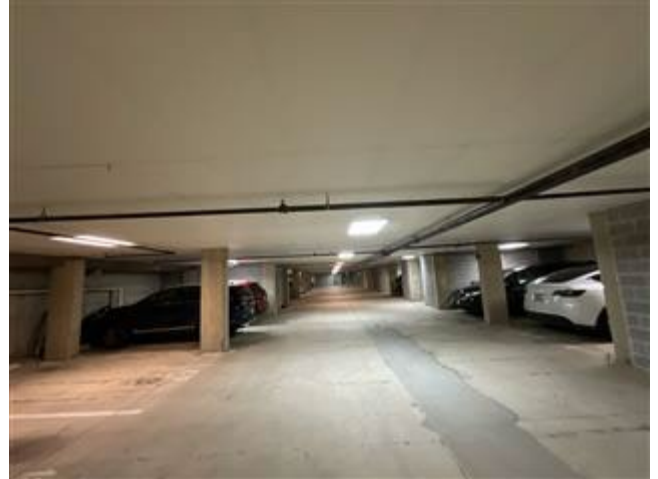
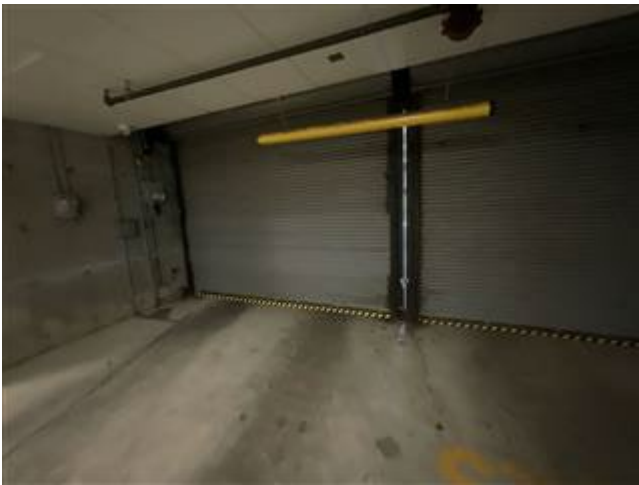
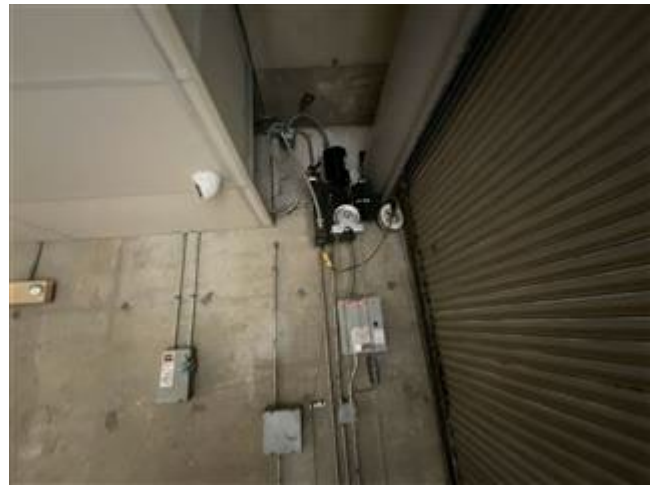
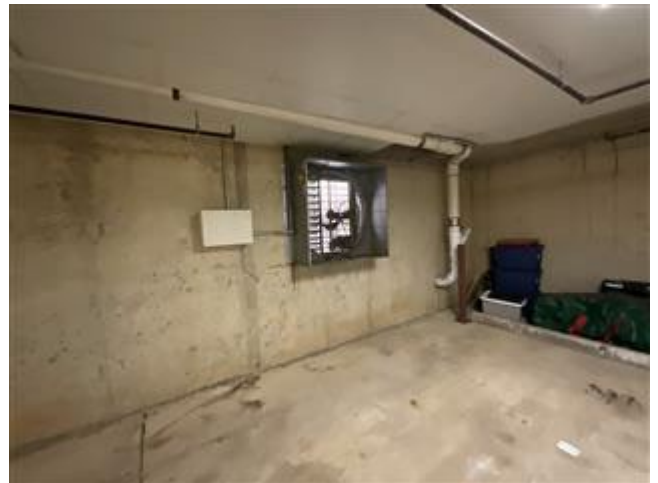
**Parking Garage.** The Association maintains two under-building parking garages. Overall the garages appear to be in good condition.

- **Flooring.** The concrete floors appear to be in good condition. We have assumed a service life of 25 years.
- **Ceiling.** The tile ceiling appears to be in generally good condition. Since it is unlikely that all ceilings will require replacement at the same time, we have provided an allowance that assumes an incremental approach.
- **Doors.** The garage doors appear to be in good condition overall. Door components typically have a service life of 20 years.
- **Fans.** The fans appear to be in good condition. Exhaust fans of this type typically have a service life of 15 years.
